**Flood Control Project Maintenance
Levee Inspections**

Fall 2019 Levee Maintenance Deficiency Summary Report

**Flood Control Project Maintenance
Levee Inspections****LMA District Cover Sheet****Fall 2019 Levee Inspection Results****Sacramento Maintenance Yard Willow Slough Bypass**

Sacramento Maintenance Yard Willow Slough Bypass

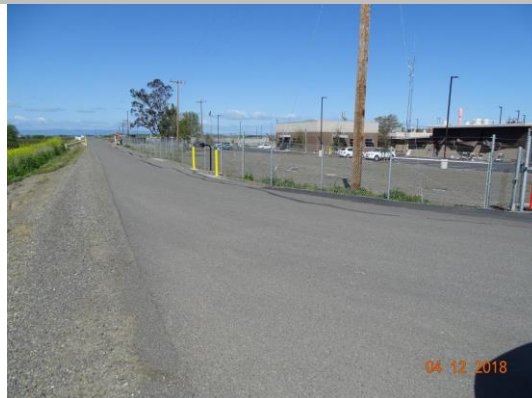
Photo 1 of 1 : FA_2019_ST0012_295_17_20190829_00006.jpg

View of fence on the landside shoulder. Spring 2018.

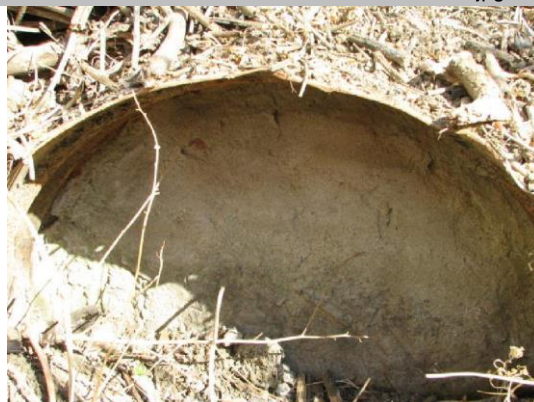
Photo 2 of 3 : UCIP_FA_2019_44904_22884.jpg

Waterside view- CMP grouted with concrete (closer view)

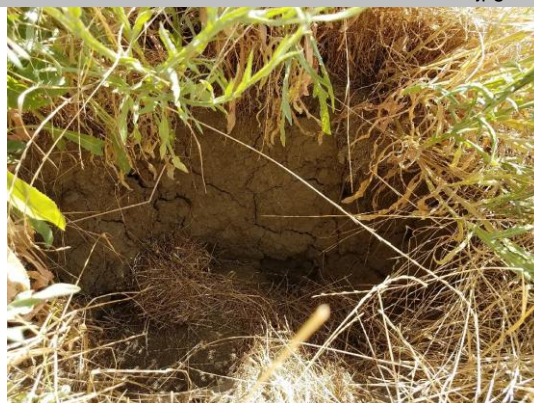
Photo 2 of 3 : UCIP_FA_2019_54247_80001.jpg

Comment Code						
Inspector Comment						
DS_ID:17612 FS_ID:54247 EP_NO: 10315 Repair Type: Non-Urgent Crossing Status: Found UCIP Comments07/01/2019 Crossing has been modified from irrigation siphon to storm drainage prior to 2012. No permit has been found authorizing the modifications to this pipe. Pipe inlet on LS is buried in soil. Sinkhole approximately 2-foot in diameter and 2-foot deep located at LS toe along pipe alignment. This crossing was internally inspected as part of the DWR's Deferred Maintenance Project in 2017. Unable to determine what happened to the pipe section through the channel and opposite levee. Coordinating with LMA and Yolo County to determine owner of crossing. (O.Yakimov - DWR UCIP) 09/19/2012 Looks 24-inch HDPE pipe sleeved through 42-inch pipe. A 30-inch flap gate on WS looks recently replaced. (DWR UCIP - P. Amatya) FIELD_STRUCT_DESC: 24-inch drainage pipe sleeved through an existing 42-inch siphon steel irrigation pipe through the levee, 13.5 feet below the crown. 42-inch pipe cut off and steel plate welded at WS toe, annular space seems to be filled with cement slurry. Pipe inlet enclosed into concrete casing on the landside (LS) end. (42-inch pipe authorized under Automatic Board Order (ABO) issued as Permit No. 10315, 1974 - Reclamation District No. 2035) [Additional Reference(s): DWR Levee Log, 1990. USACE Sacramento O&M Manual Unit 120, Willow Slough Channel Relocation and Levee Construction, February 1947, Drawing No. 50-4-2281 Sheet 2 (Station 193+70)] FS Date: 7/1/2019 3:27:02 PM

Closeup view of sinkhole

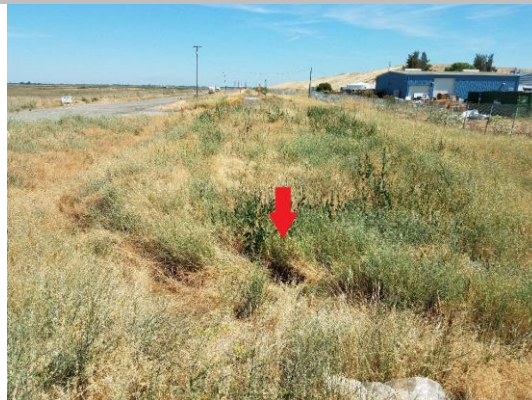
Photo 3 of 3 : UCIP_FA_2019_54247_80002.jpg

DS_ID:17612
FS_ID:54247
EP_NO: 10315
Repair Type: Non-Urgent
Crossing Status: Found
UCIP Comments: 07/01/2019 Crossing has been modified from irrigation siphon to storm drainage prior to 2012. No permit has been found authorizing the modifications to this pipe. Pipe inlet on LS is buried in soil. Sinkhole approximately 2-foot in diameter and 2-foot deep located at LS toe along pipe alignment. This crossing was internally inspected as part of the DWR's Deferred Maintenance Project in 2017. Unable to determine what happened to the pipe section through the channel and opposite levee. Coordinating with LMA and Yolo County to determine owner of crossing. (O.Yakimov - DWR UCIP)
09/19/2012 Looks 24-inch HDPE pipe sleeved through 42-inch pipe. A 30-inch flap gate on WS looks recently replaced. (DWR UCIP - P. Amatya)
FIELD_STRUCT_DESC: 24-inch drainage pipe sleeved through an existing 42-inch siphon steel irrigation pipe through the levee, 13.5 feet below the crown. 42-inch pipe cut off and steel plate welded at WS toe, annular space seems to be filled with cement slurry. Pipe inlet enclosed into concrete casing on the landside (LS) end. (42-inch pipe authorized under Automatic Board Order (ABO) issued as Permit No. 10315, 1974 - Reclamation District No. 2035) [Additional Reference(s): DWR Levee Log, 1990. USACE Sacramento O&M Manual Unit 120, Willow Slough Channel Relocation and Levee Construction, February 1947, Drawing No. 50-4-2281 Sheet 2 (Station 193+70)]

Sinkhole at LS toe at pipe alignment

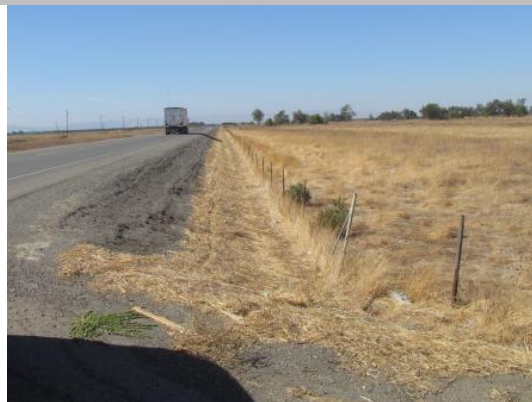
Photo 1 of 1 : FA_2019_ST0012_295_14_20190829_00005.jpg

LM Start	1.53	Rating **	M	Issue No.	14
LM End	2.20	Issue Type +	En	Location *	LS
Category	Earthen Levee			GPS Latitude/Longitude	
				Start	End
Item	Encroachments			38.590334 °	38.590466 °
				-121.693618 °	-121.705849 °
DWR ID	DWR_ST0012_01_f_2016_14				
Comment Code					
FE : Fence					
Inspector Comment					
There is a barbed wire fence along this section of levee.

View of fence encroaching 10-foot easement on landward side of the levee. Fall 2016.

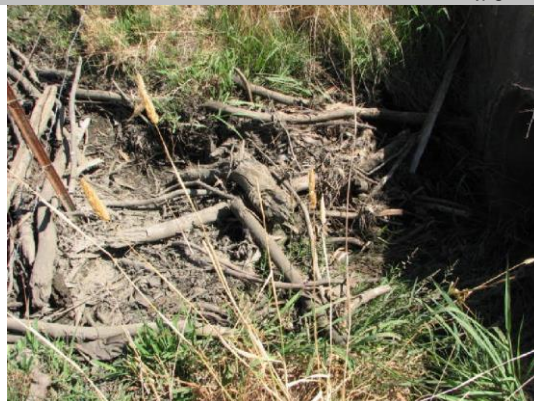
Photo 2 of 3 : UCIP_FA_2019_44937_22949.jpg

Landside view- debris

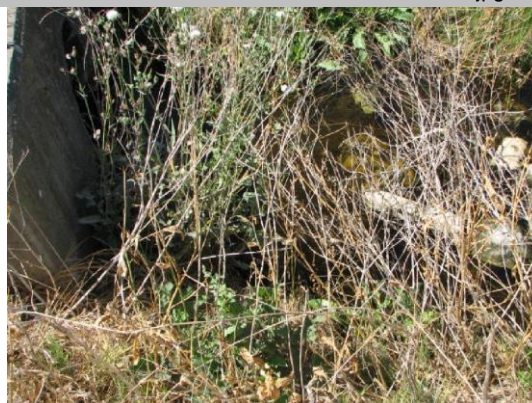
Photo 3 of 3 : UCIP_FA_2019_55422_22960.jpg

Landside view- vegetation around inlet.

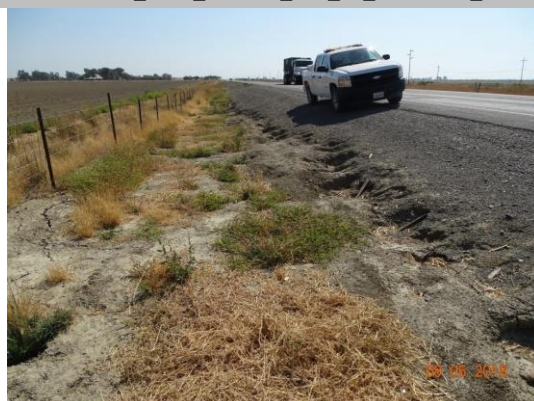
Photo 2 of 3 : FA_2019_ST0012_295_10_20190829_00003.jpg

Additional view of the erosion on the landside slope. Fall 2018.

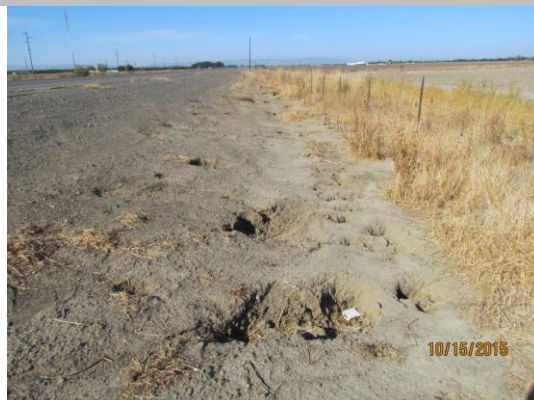
Photo 3 of 3 : FA_2019_ST0012_295_10_20190829_00004.jpg

View of the erosion on the landward side of the levee looking upstream.
Fall 2015.

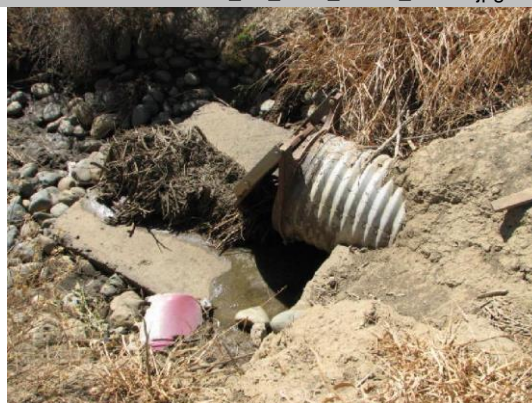
Photo 2 of 3 : UCIP_FA_2019_44947_22983.jpg

Waterside view- pipe, flap gate and debris.

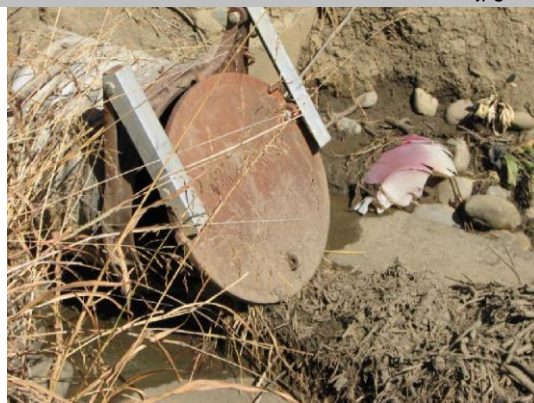
Photo 3 of 3 : UCIP_FA_2019_44947_22986.jpg

Waterside view- pipe, flap gate and debris. The pipe sits on concrete saddle.

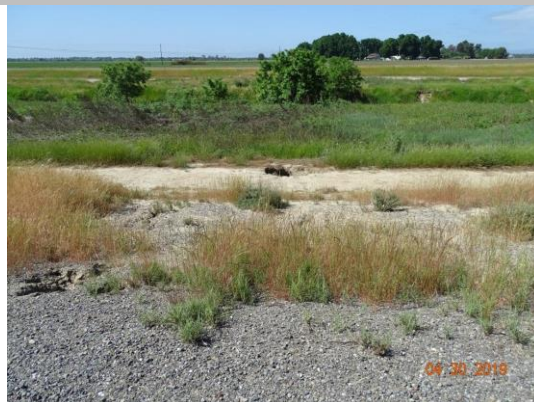
Photo 1 of 1 : FA_2019_ST0012_295_23_20190829_00007.jpg

LM Start	3.69	Rating **	M	Issue No.	23
LM End	3.69	Issue Type +	Ma	Location *	WS
Category	Earthen Levee			GPS Latitude/Longitude	
				Start	End
Item	Erosion / Bank Caving			38.591699 °	38.591699 °
				-121.733066 °	-121.733066 °
DWR ID	DWR_ST0012_01_s_2019_23				
Comment Code					
E2 : Schedule repair of erosion site prior to the next inspection.					
Inspector Comment					
Appears to be runoff erosion on the waterside slope and toe road.

View of hole on the toe road. Spring 2019.

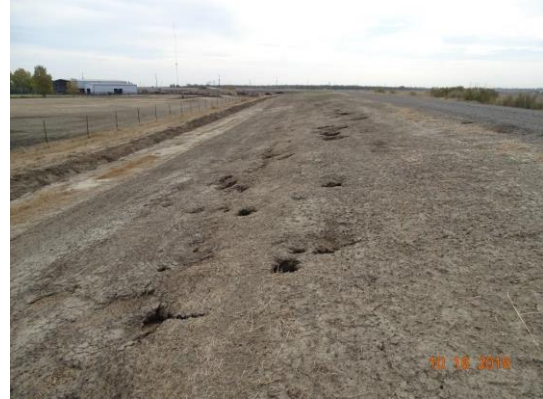
Photo 1 of 1 : FA_2019_ST0012_295_20_20191108_00035.jpg

View of sinkholes on the landside slope. Fall 2019.

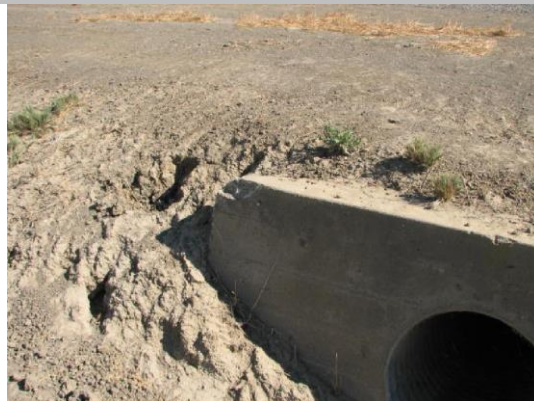
Photo 3 of 3 : UCIP_FA_2019_13725_22468.jpg

Landside view- concrete headwall corner chipped off

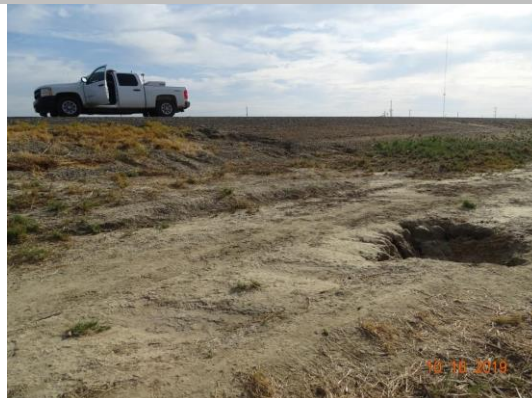
Photo 1 of 1 : FA_2019_ST0012_296_24_20191108_00049.jpg

View of erosion on waterside slope and toe road. Fall 2019.

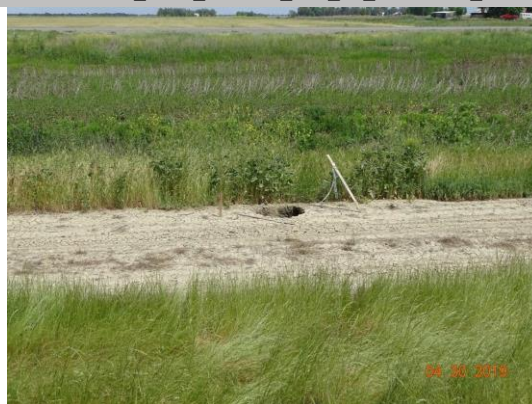
Photo 1 of 1 : FA_2019_ST0012_296_28_20190829_00006.jpg

View of erosion on the waterside toe road. Spring 2019.

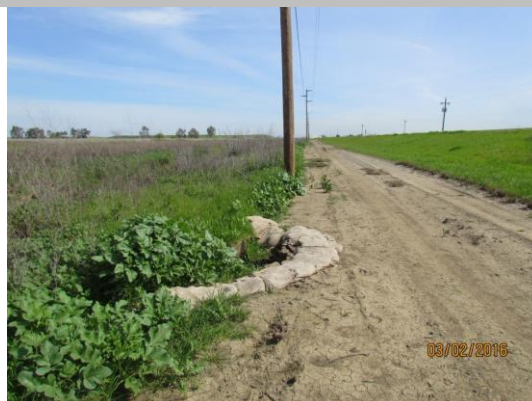
Photo 2 of 2 : FA_2019_ST0012_296_10_20190829_00005.jpg

View of the erosion on the toe road looking downstream. Spring 2016.

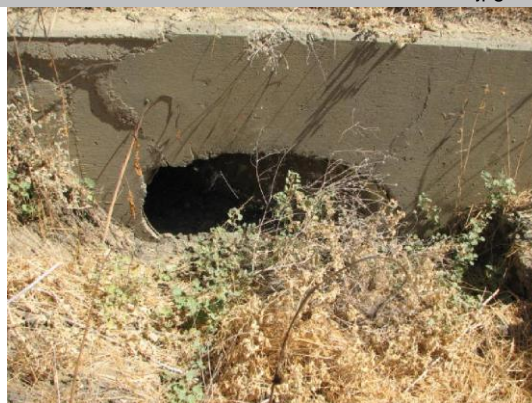
Photo 3 of 3 : UCIP_FA_2019_45285_22810.jpg

Landside view- soil and debris on mouth of the inlet pipe.
